CASE STUDY

PIPE HANGER CONDITION ASSESSMENT FOR HRSG AND BOP *Sample*

Project: HGPI Outage & MI Outage

Location: Telok Kong, Melaka, Malaysia

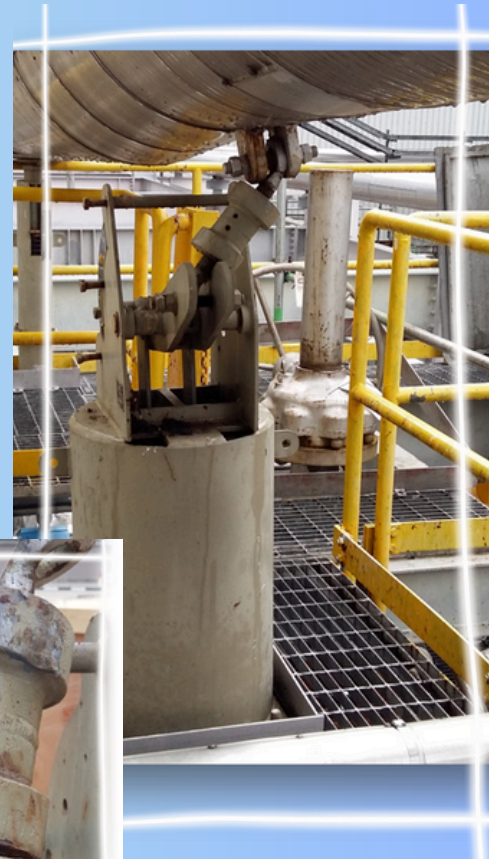
Damaged pipe supports

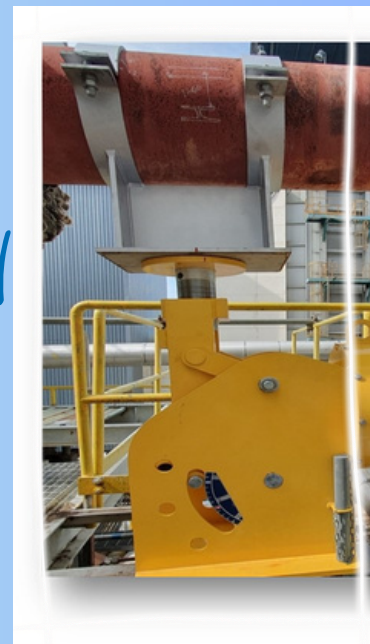
New pipe supports replaced
